## Case Study: Gujarat Earthquake

### 2001 Bhuj Earthquake: Preliminary Report from IITKanpur

### **Chamoli (Himalaya, India) Earthquake of 29 March 1999**

### The September 29, 1993, M6.4 Killari, Maharashtra Earthquake in Central India.

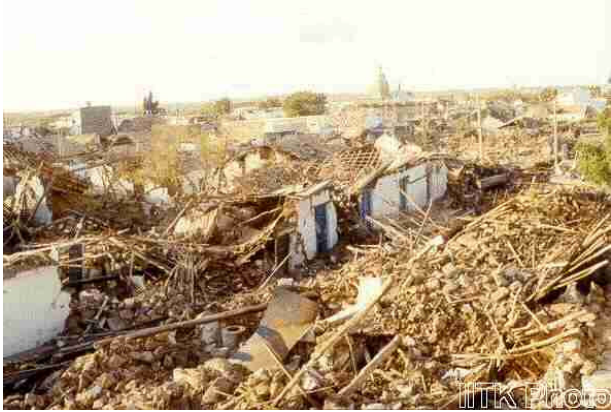
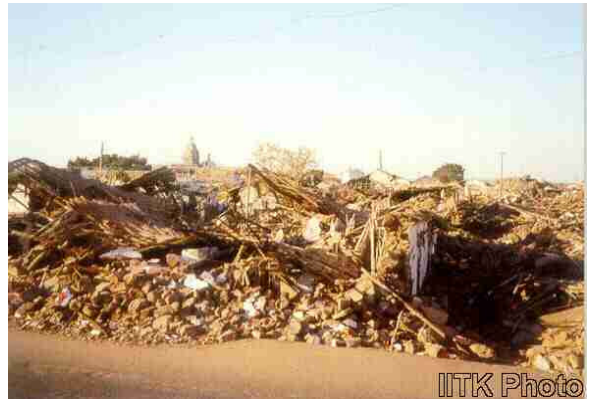
A common site of destruction of the villages in the meizoseismal area.

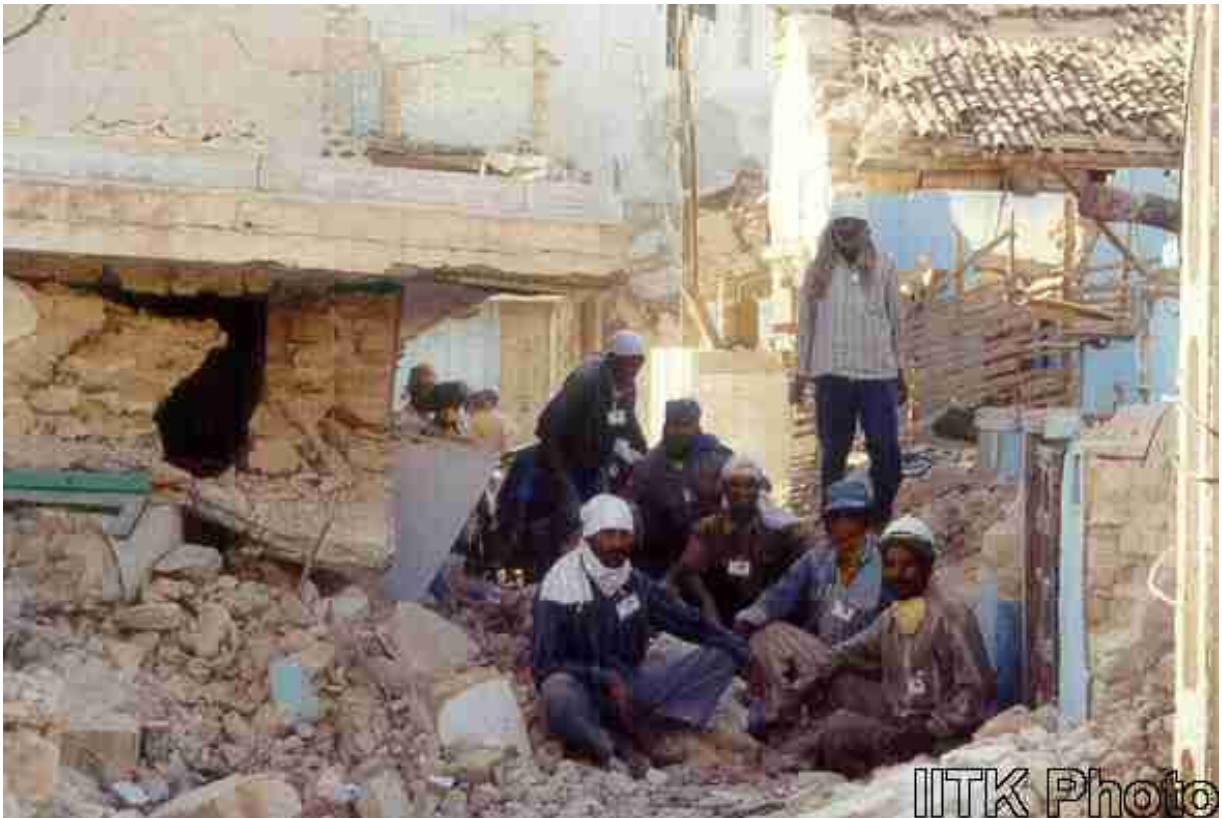
Rubble of collapsed buildings being cleared at Anjaar. Narrow lanes caused significant casualties and made rescue and relief very difficult. Kudos to the rescue/relief workers for their daring efforts!!

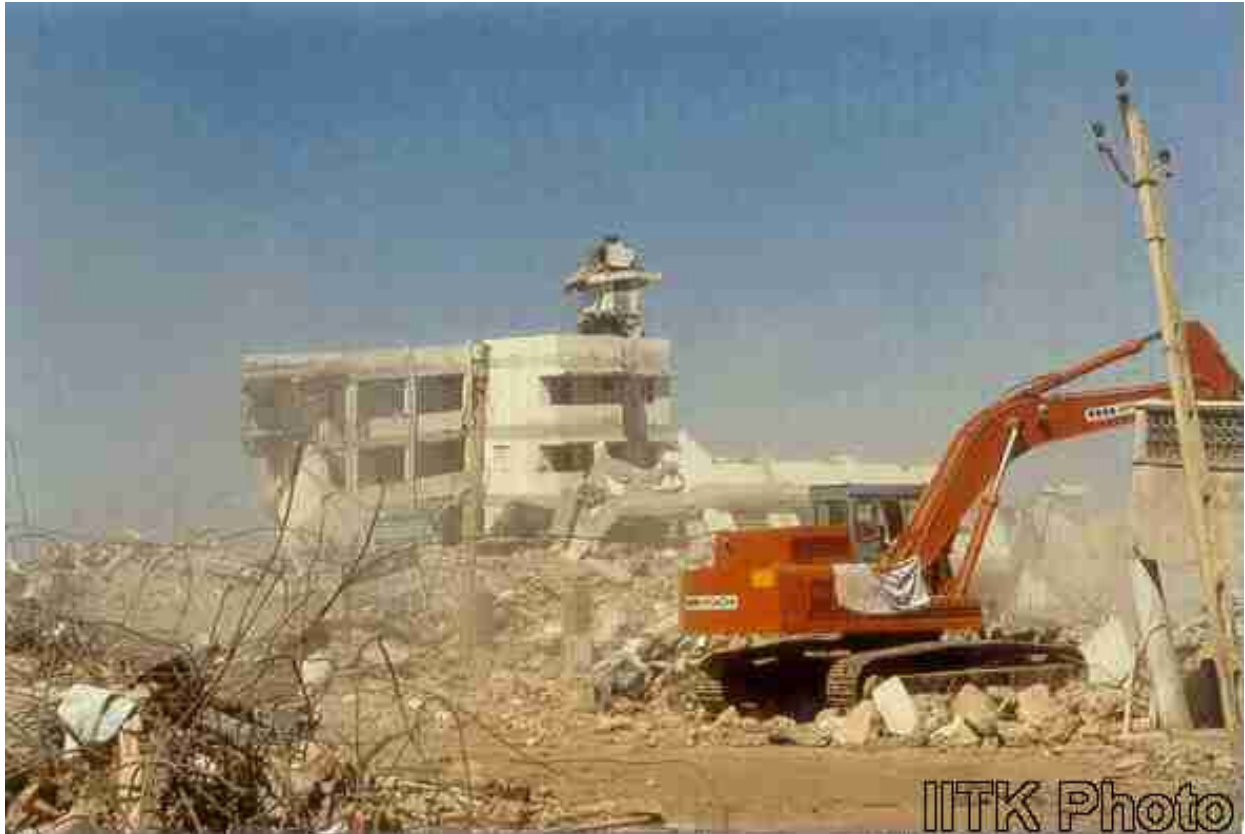
Virtually nothing could be recovered from most RC frame buildings that collapsed. Clearing of debris from collapse of numerous multistorey RC frame buildings was an even bigger challenge.

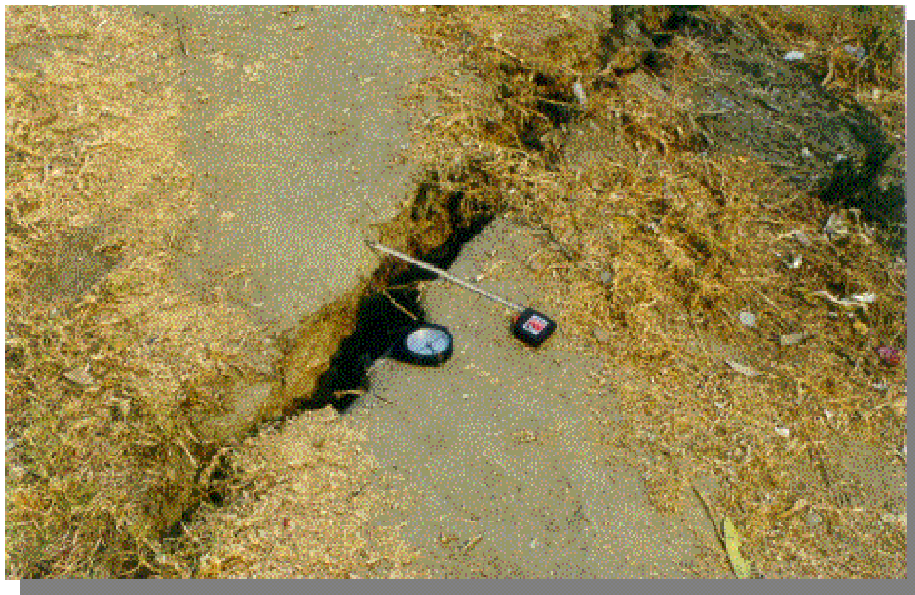
*Figure 5:* Ground fissure at Telecom Hill near Gopeshwar

Ground cracks at several places also developed as part of slope failure and these pose threat to the down-slope settlements. Cracks were seen in asphalt roads at some locations, indicating the possibility of failure due to ground slippage. At several sites, large-scale earthquake-induced landslide/rock falls were observed (*Figure 6*). Those near Gopeshwar, Chamoli and Gadi continued even after a fortnight of the event. Interestingly, these rockslides are also confined to locations along MCT-I.

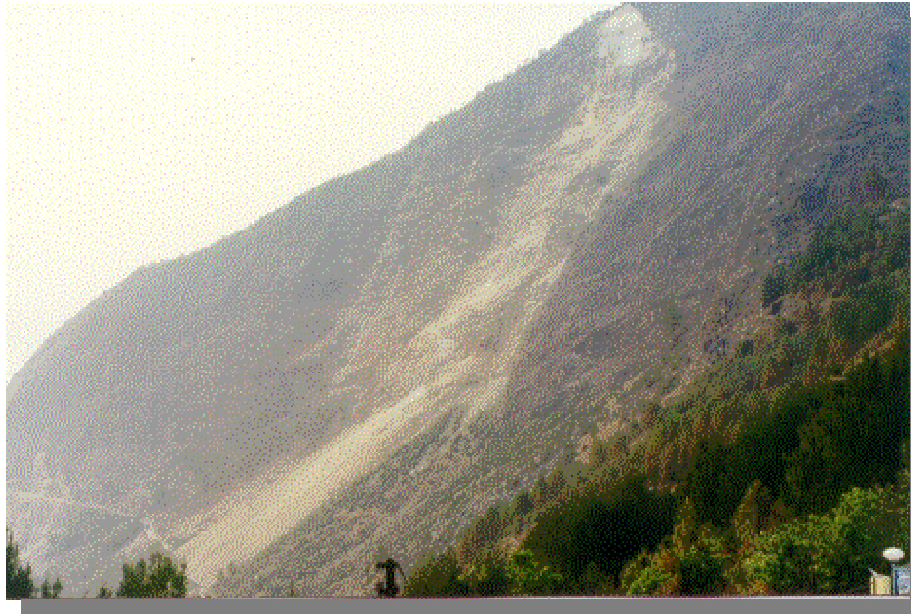
*Figure 6:* A major landslide about 1km north of Gopeshwar. It blocked the road traffic to Okhimath for a considerable period.

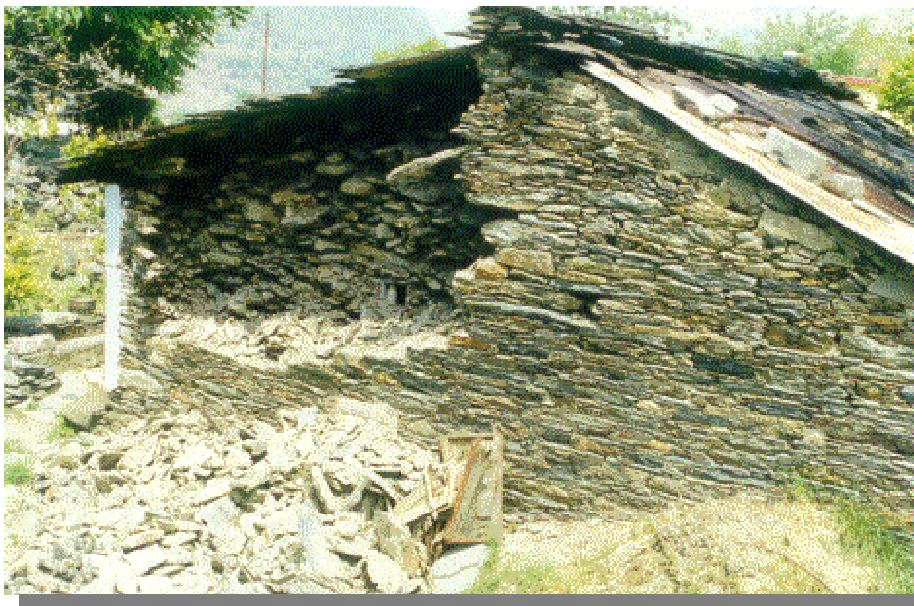
*Figure 7:* Collapse of one of the wythes in a traditional house in slate wafer masonry.

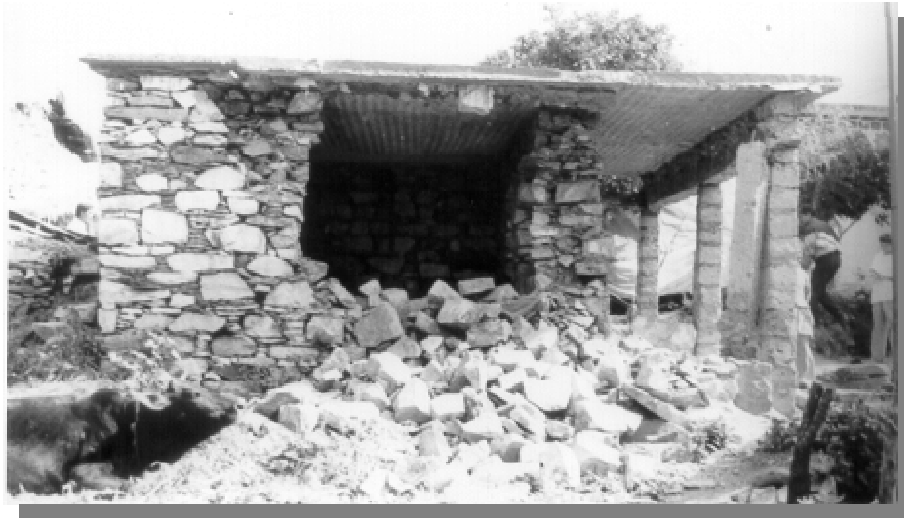
*Figure 8:* Partial collapse in a random rubble stone masonry. Note that the front portion has RC beam supported on concrete block columns and roof consists of RC slab

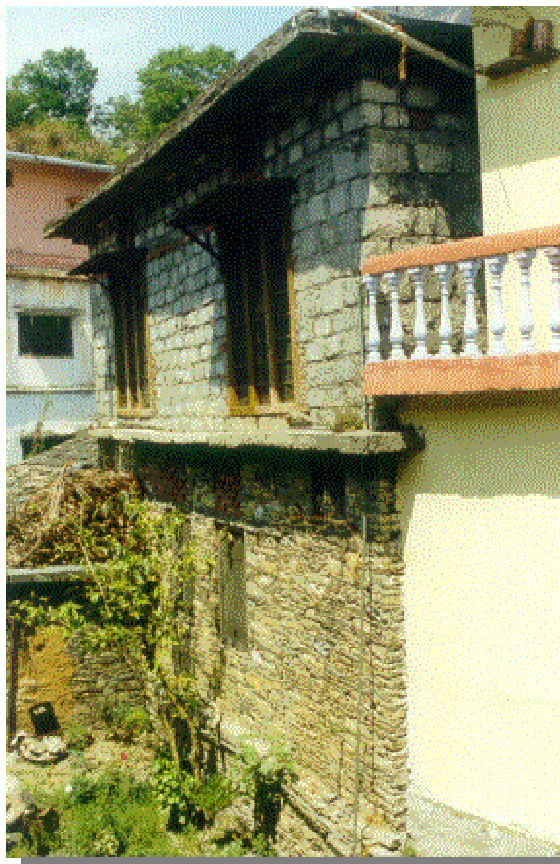
*Figure 9:* Two-storey house at Pipalkoti with no damage. Ground storey in slate wafer masonry, upper storey added later in concrete block masonry. Both storeys have RC lintel band

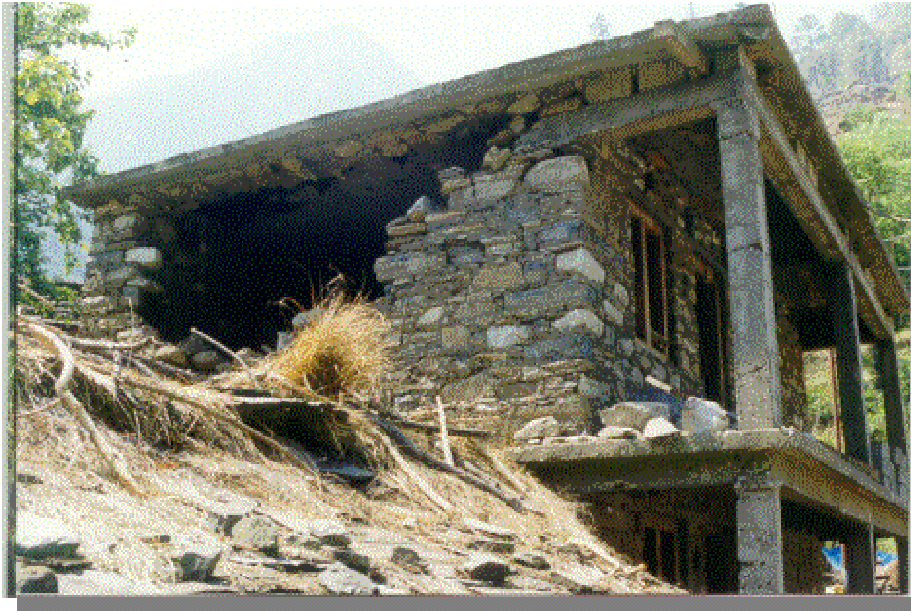
*Figure 10:* Partial collapse in a stone masonry house at Gadi village. Lintel band, present in the front portion, does not continue in the side wall

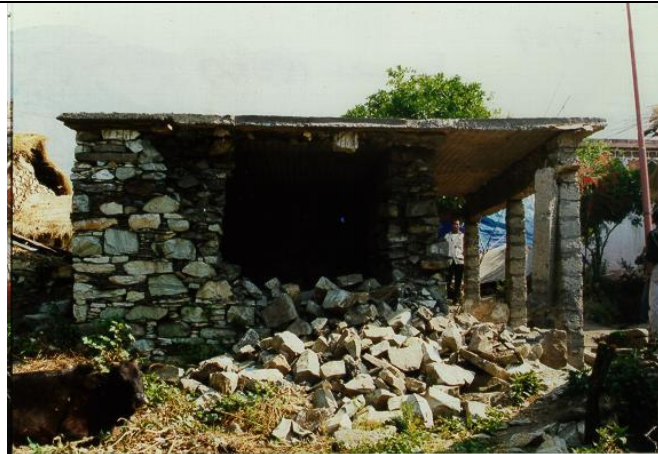
**P1.** Partial collapse in a random rubble stone masonry building. Note that the front portion has RC beam supported on concrete block columns, and that the roof consists of an RC slab.

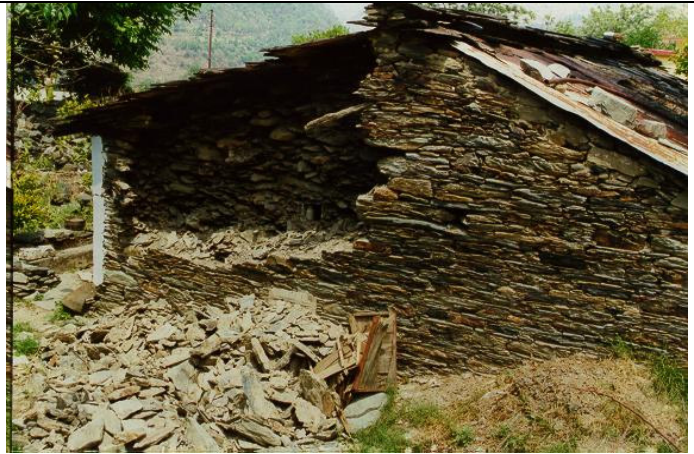
**P2.** Collapse of one of the wythes in a traditional house in slate wafer masonry

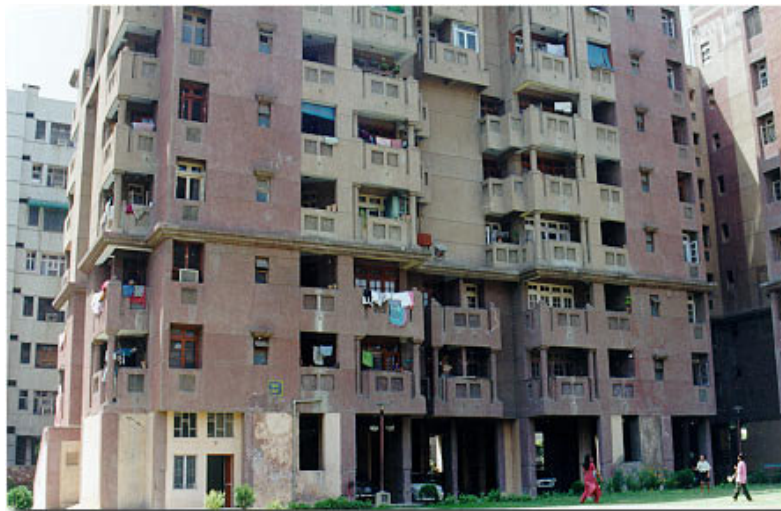
**P3.** Tarang Apartment in Delhi that sustained damage to infill walls.

**Nonstructural damage to some buildings in far-off Delhi clearly underlines the potential for a major disaster there.** Considering the political and social significance of such an eventuality, efforts should be directed towards effective earthquake disaster mitigation and management in the Indian capital.

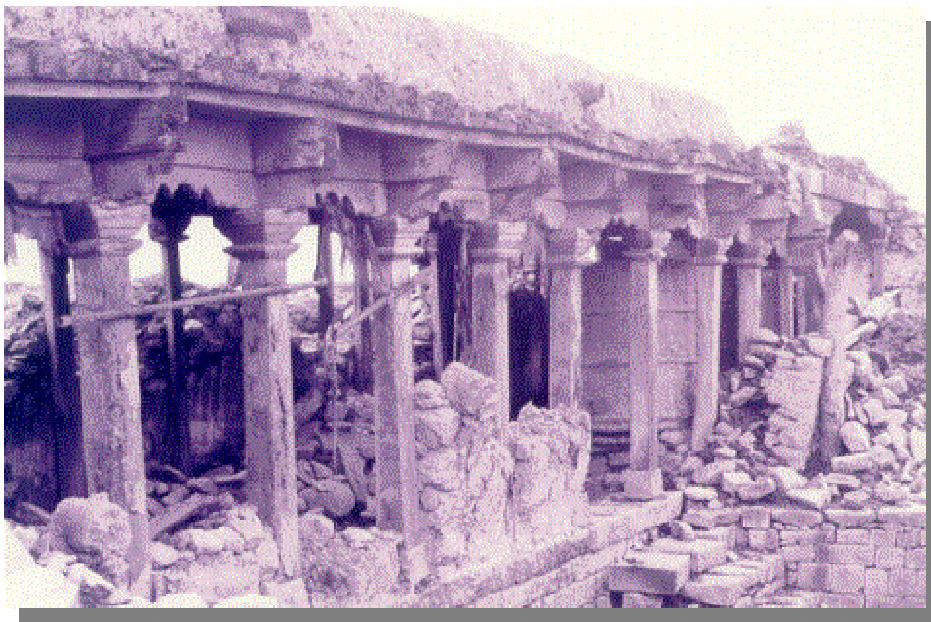
*Figure 4:* In some buildings, the traditional heavy clay roof was supported on a frame of wood posts and beams. In most cases, the timber columns continued to hold the roof together while the walls collapsed, generally outwards from the timber frame, saving the lives of many occupants

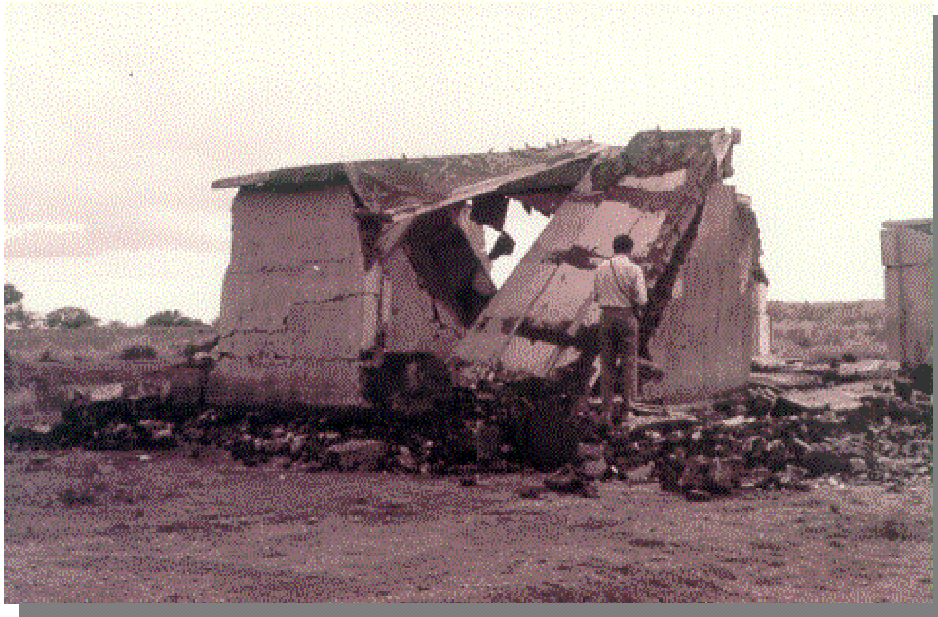
*Figure 5:* A brick masonry school building in Rajegaon collapsed. The roof of precast panels lacked adequate connections

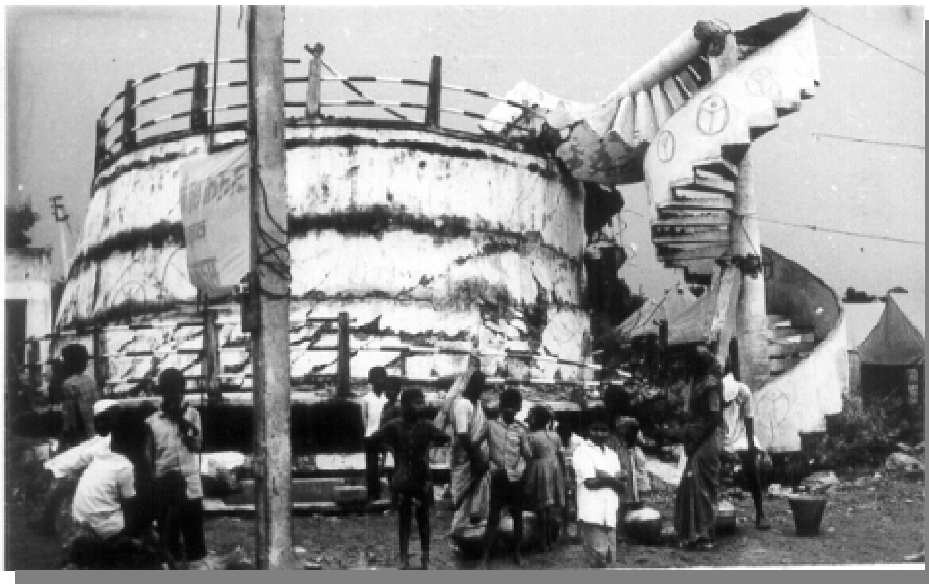
*Figure 6:* While most elevated water tanks performed well, this tank of Kautha collapsed straight down into its crumpled supports. Circumferential displacement of about 0.5m suggests that rotational vibration led to its collapse.

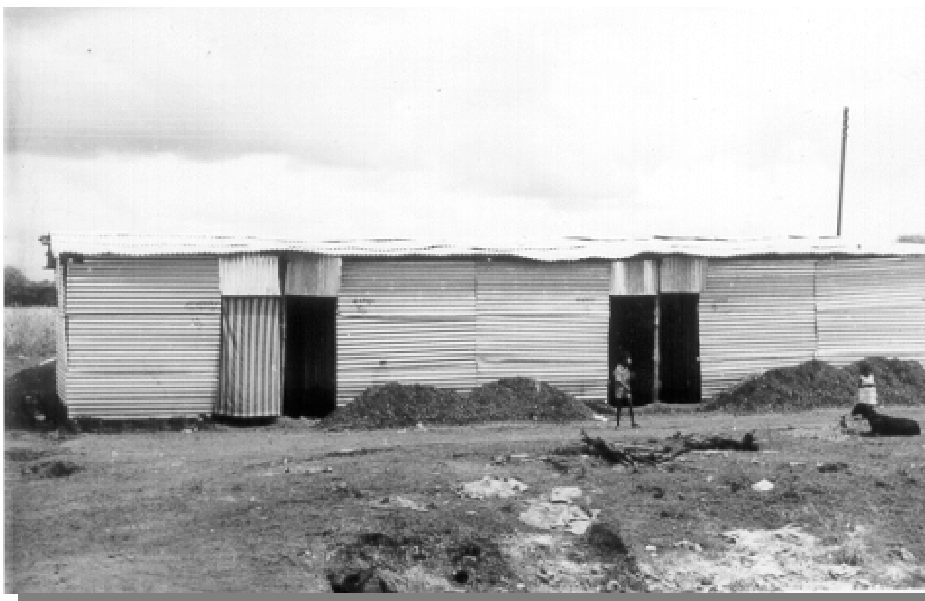
*Figure 9:* Temporary shelters of galvanised iron sheet were rapidly erected. Each provides shelter for five families

*Temporary Shelter:* Immediate shelter was provided by erecting temporary galvanized iron sheet houses. Each shelter consisted of 5 units of about 15 m<sup>2</sup> areas each; each affected family was offered one such unit. Common toilets and hand operated bore wells were provided. Some families chose to take tents and tin sheets instead and made their own shelters.
